Manhole Inspection Summary

Manhole # S17C1_020MH

Insp Date: **5/15/08 1:20 PM**

Location Address: **2801 letitia av**

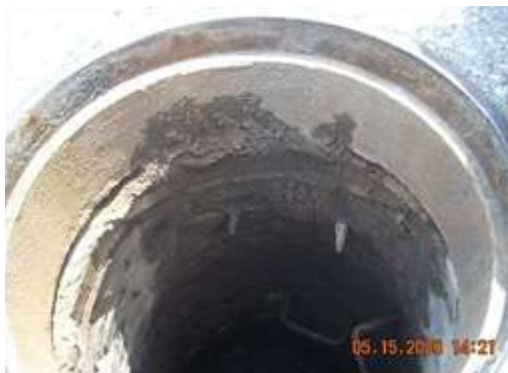
Defect 3

☒ **Leaks**

Frame leaks-inflow evidence

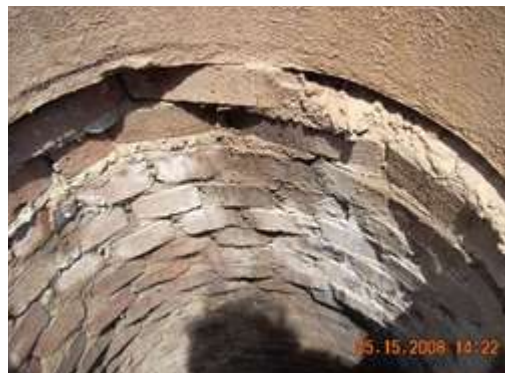
Defect 4

Infiltration: ☐ None ☒ **Joint** ☐ Cracks ☐ Mortar ☐ Roots ☐ Wall

infiltration @ chimney/frame joint

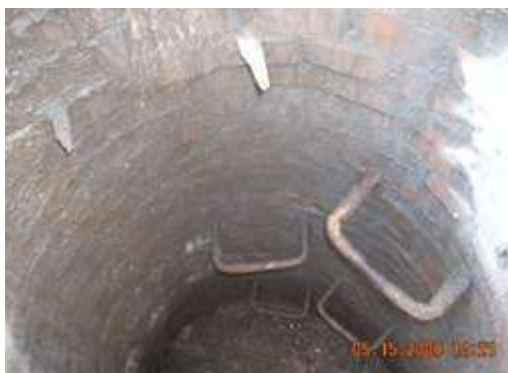
Defect 2

Count: **4** Missing: **1** ☒ **Corroded**

corroded & missing steps

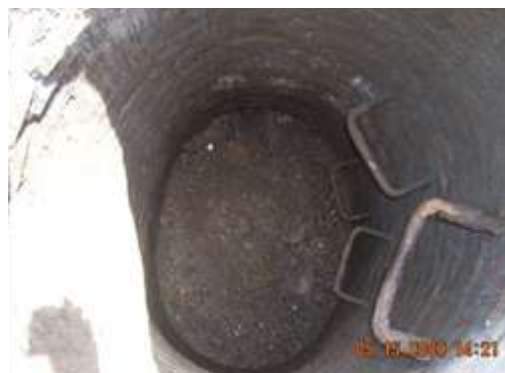
Defect 1

Condition: ☐ Sound ☐ Cracked ☐ Root Intrusion ☐ Deteriorated ☐ Leaks ☒ **Debris**

debris in terminal channel

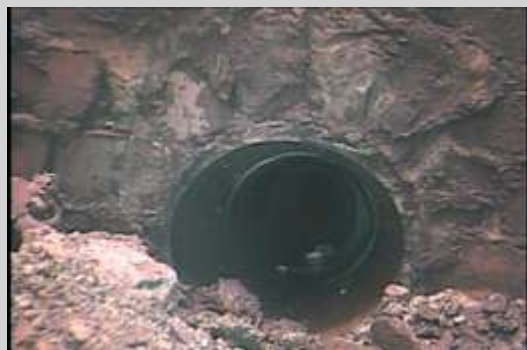
12 O'Clock Outflow

Deposits: ☐ None ☒ **Mud** ☐ Sludge ☐ Debris ☐ Grease

Silt Depth: **1** (in.) Deposits Extent: **Light**
